**SAS Superstructure**

Daily Diary Report by Bid Item

Contract No.: 04-0120F4

Diary #: 744 Const Calendar Day: 199 Date: 20-Dec-2012 Thursday

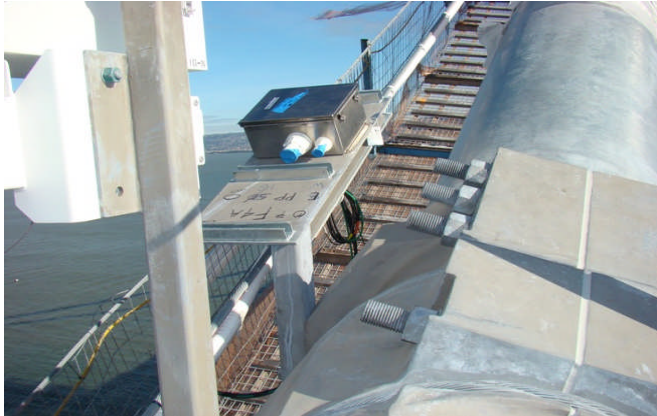
Close up of an electrical pullbox and structural attachment on cable band WPP16.

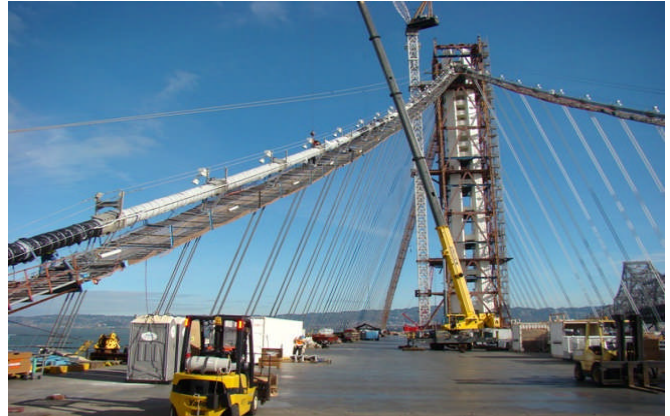
installing electrical pull-box stands on the North Sidespan cable bands starting at panel point 10N. The requirement of this attachment to the cable band is a snug tight bolted connection after applying "locktight" substance into the tapped hole. Abbas Irashmanesh is back from vacation and he took over inspection duties after lunch even though I have the ironworkers listed in my diary. See his diary for more details of the installation of this electrical attachment to the cable band. When I left the field the ironworkers installed the electrical attachments up to panel point 32N. Also it should be noted that Sam Patel may be watching certain aspects of this installation since it pertains to electrical work.

ABF ironworkers seen attaching electrical pull boxes and supports on the North Sidespan.

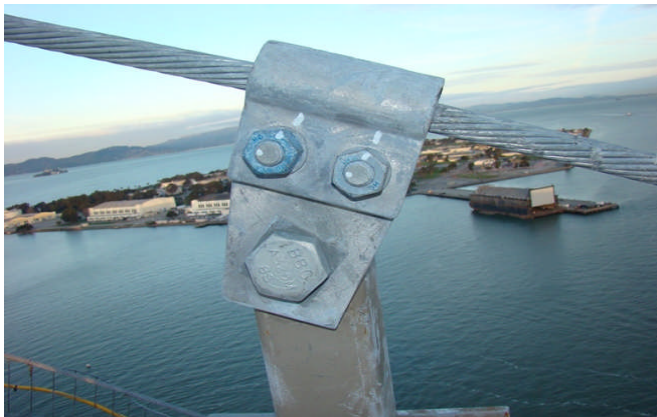
- Completed the first iteration of fastening the North Mainspan handrope clamp bolts to a 1/3 turn or a torque of 302N-m. Mario and Sergio started from WPP46 and stopped at WPP62 using a standard wrench to snug the bolt, match mark 1/3 turn, then apply the 1/3 turn. Similarly Rigo and Javier resumed tightening these bolts at WPP80 uphill to WPP64 using the electrical impact wrench.

After testing the handrope clamp bolts I verbally informed ABF engineer Ankur Singh that the torque applied to the bolts from WPP64 to WPP100 were unacceptable. Also mentioned the few bolts that failed from WPP46 to WPP62. Since the South Sidespan bolts were also torqued with a electrical impact wrench and the inspection torque yesterday was questionable I informed Ankur that all those bolts failed and need to be checked again.

Typical match marks seen on the North Mainspan handrope clamp from WPP46 up to WPP62.

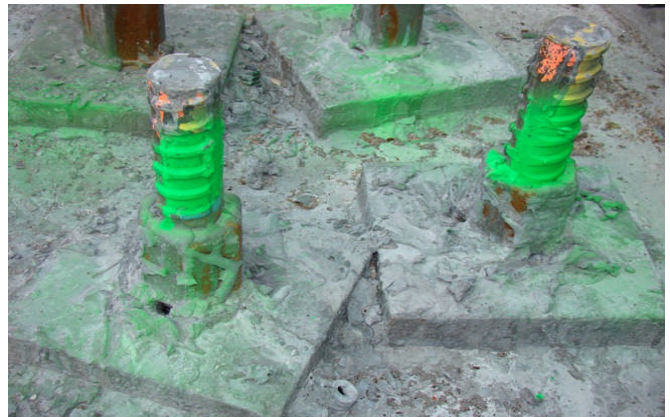
Short vertical PT bars on the E-Line which are spray painted green, denoting that it's unclear weather or not the full length of the rod was grouted.
